CITY OF EMPORIA

TO: The Honorable Mayor and City Council
FROM: Brian S. Thrower, City Manager *BST*
SUBJECT: Police Station and City Hall – Request for Council Decision
ITEM #: 17-87

FACILITIES ASSESSMENT / TASK 2

City Hall

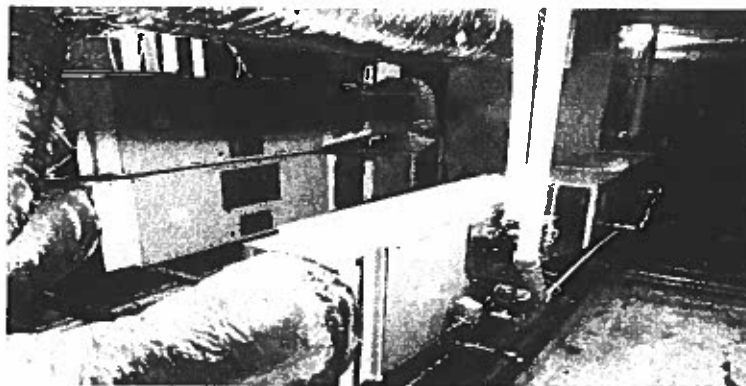
The HVAC system is a mixture of original equipment from 1979 and replacement equipment installed over numerous years from 1997, 2007, and 2012. The original system consisted of (2) Multizone Roof top variable air volume units with refrigerant based cooling coils and LP gas heat exchangers. Each unit served modulating dampers in the ductwork to provide individual zone control. Around 1997, these units were replaced. The replacement units were actually residential style split system units that were connected together and ducted into the existing supply and return duct connections on the roof. Since the residential style air handlers were designed to be mounted inside, a roof was built over the existing brick mechanical screens at each end of the building. Individual condensing units were mounted on the flat roof adjacent to the new enclosed equipment screens. This type of installation is most unusual and cannot possibly provide the zone and temperature control desired by the building occupants. The air handling units cycle during the day and do not provide constant air motion. The original units provided ventilation air from outside to the building. The replacement units do not provide any of the code required outside air. Typical life expectancy for this type of equipment is 15-20 years.

A photo of the main HVAC equipment at one end of the building is shown below:
